CASE STUDY

SMALL SOLUTION, HUGE COST IMPACT

**JÄGER GROUP DEVELOPS
DECISIVE ASSEMBLY PROTECTION
FOR ROTOR BLADE BOLTS**

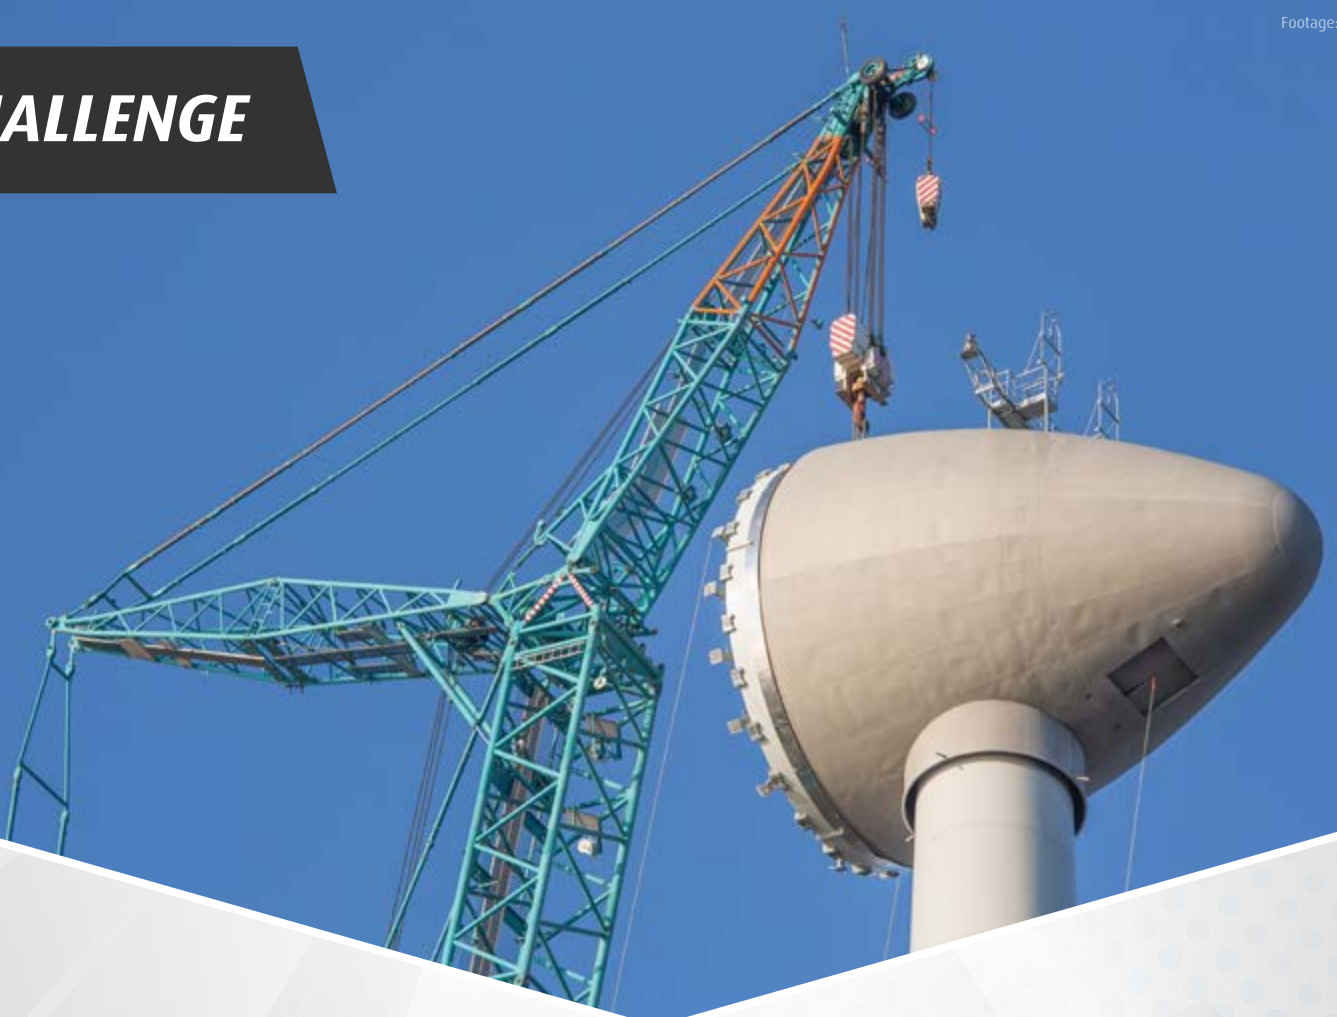
FAULT-FREE INSTALLATION AT A LOFTY HEIGHT

The assembly of rotor blades is a highly complex process. Depending on the system type, at least 54 bolts must be aligned to the alignment of the corresponding rotor blade hub opening. A process with large weights on the crane, swinging at lofty heights. This does not always succeed without problems and can lead to damages on the rotor blade bolts. And damaged bolts can corrode with time and lose stability. In this case, high costs would be the consequence.

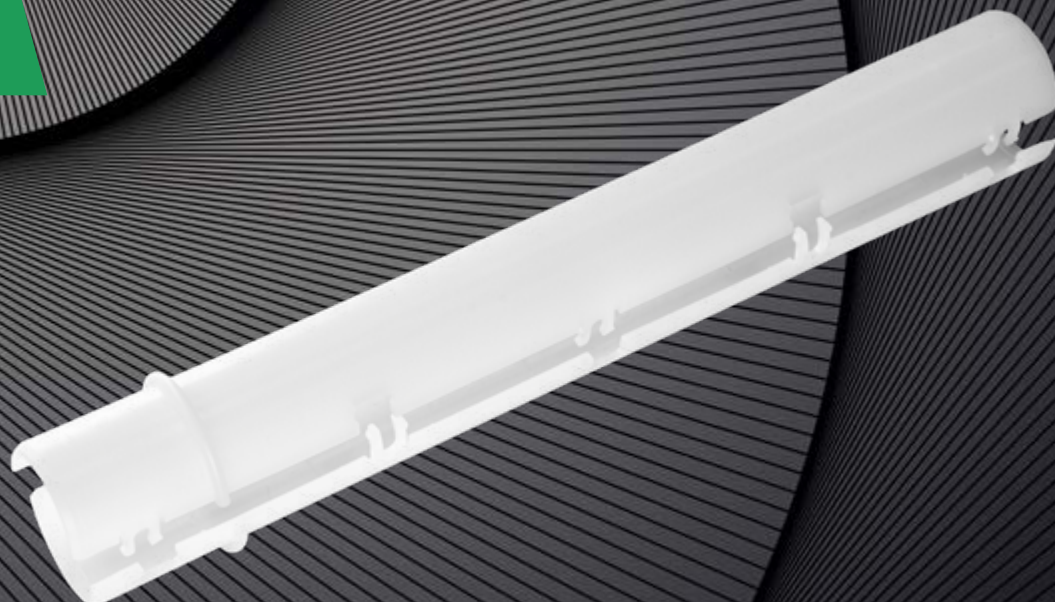
ONE-KLICK SOLUTION: HALF SHELLS

The JÄGER experts propose an alternative: two half shells lockable with each other, manufactured with injection molding.

The basic idea seems so simple and convincing: Two half-shells hug the area of the extension shaft and are

connected via a click lock. The half-shells are made of PP (polypropylene) and offer the right average between stability and dimensional tolerance of the extension shaft.

In order that the bolts are centered to the hub inside the throughway opening during the assembly process of the rotor blade the half-shell receives a slim, circumferential bulge at one place. This does not only protect the scratch-sensitive surface from material damage. The rotor blade bolt is fixed on the hub using a nut, keeping the protection of the extension shaft in the system.

PP half-shells as assembly protection for rotor blade bolts

Simple assembly principle via click lock
